REPAIRING ALUMINUM WIRING

U.S. Consumer Product Safety Commission
Bethesda, MD
www.cpsc.gov
www.SaferProducts.gov

Publication 516

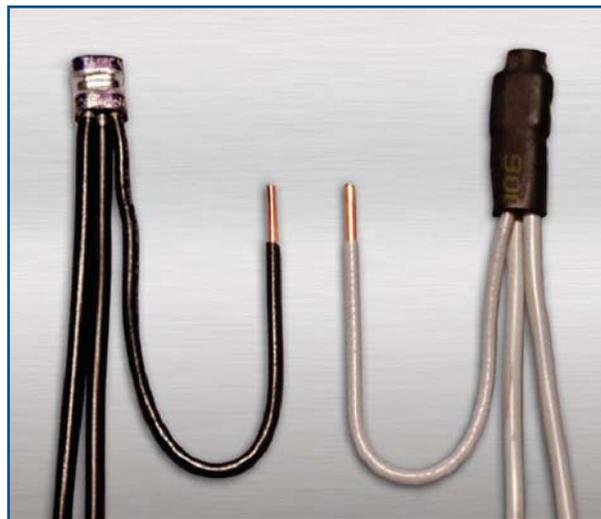
The COPALUM connector is a specially designed system that includes a metal sleeve intended to be installed only with a dedicated power tool and crimping die to make a permanent connection, that is, in effect, a cold weld (the precision dies in the COPALUM tool compress the connector and wires using upwards of 10,000 pounds of force, as required to make the permanent aluminum wire connection).

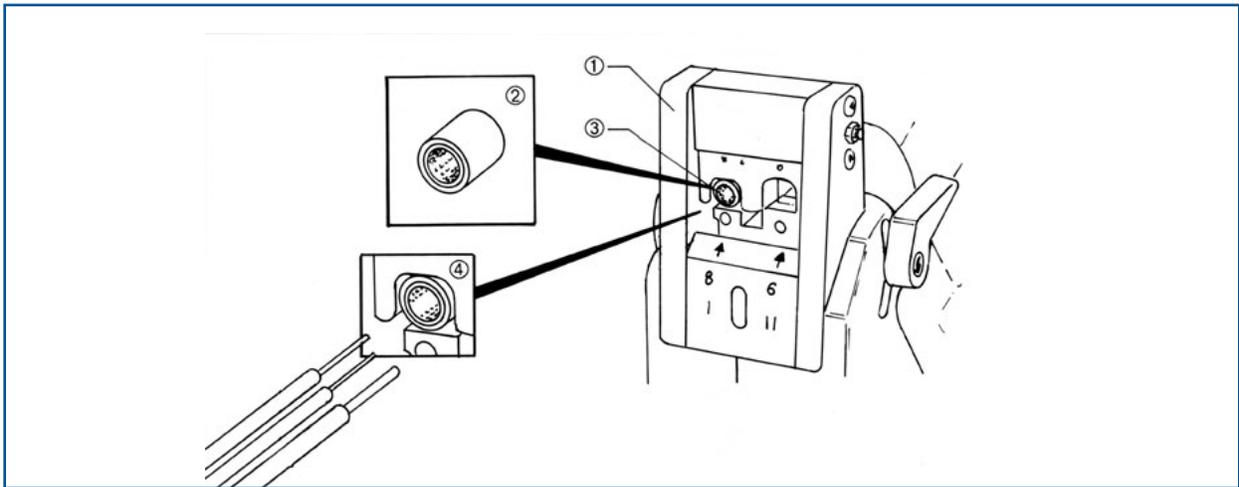
The tool is shown in the illustration below. An insulating sleeve is placed around the crimp connector to complete the repair. The copper wire pigtail is then connected to the switch, receptacle, or other termination device. An example of a repaired receptacle outlet is also illustrated below.

COPALUM Crimp Connector and its Specialized Installation Tooling

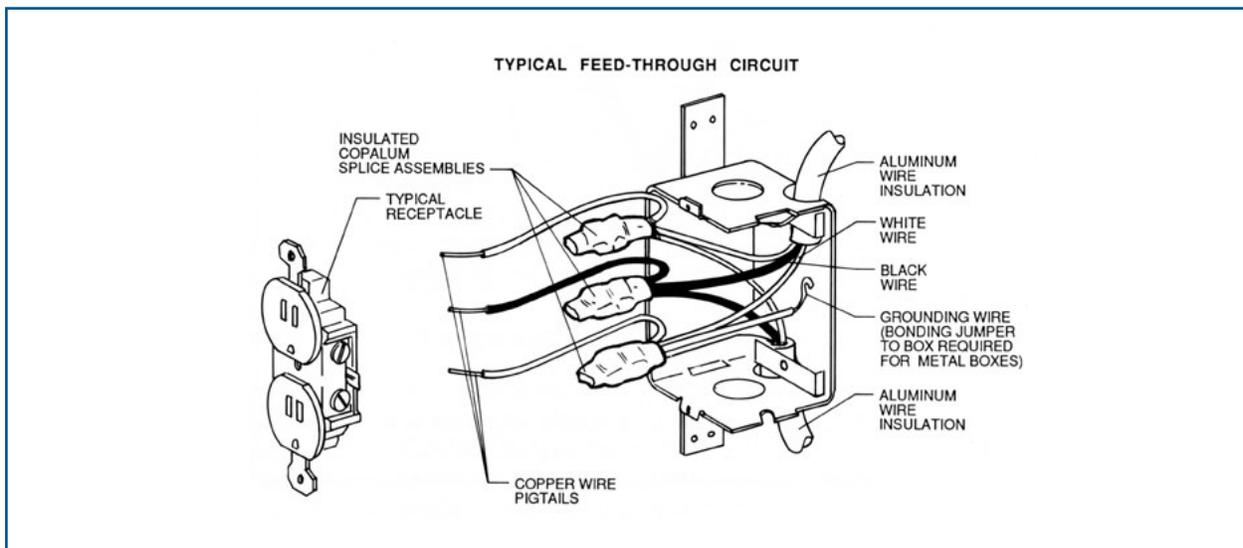
Recommended COPALUM Connector Repair

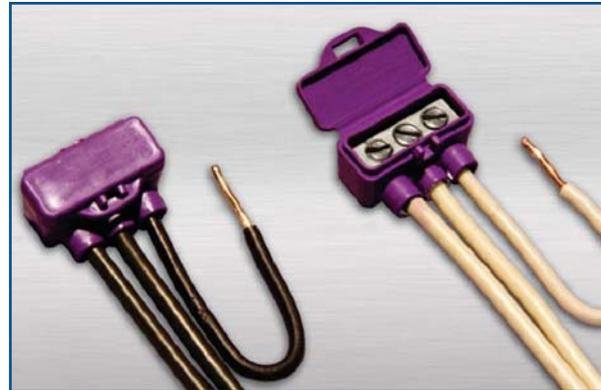
The AlumiConn Connector

CPSC staff recognizes that copper replacement may be cost prohibitive and that the COPALUM repair may be unavailable in a locality. Based upon an evaluation that was, in part, CPSC supported,⁵ consumers are advised that, if the COPALUM repair is not available, the AlumiConn connector may be considered the next best alternative for a permanent repair. This repair method involves pigtailing using a setscrew type connector instead of the COPALUM crimp connector in the repaired connections. The AlumiConn connector has performed well in initial tests, but is too new to have developed a significant long-term safe performance history as the COPALUM repair. The repair should be conducted by a qualified electrician because careful, professional workmanship and thoroughness are required to make the AlumiConn connector repair safe and permanent.

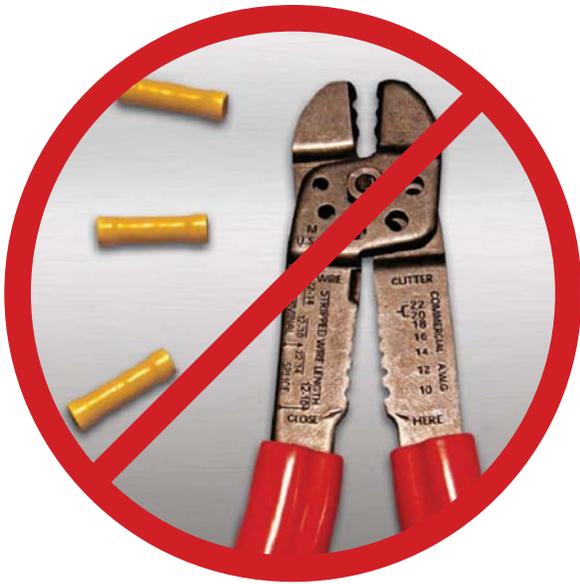
Do Not Use Common Hand-Crimped Connectors with Aluminum Wire

There are many other brands and types of crimp connectors – including those intended to be installed with a pliers-type of handtool – which are readily available to consumers at common retailers.

No other crimp connectors have been evaluated for connecting copper and aluminum conductors. CPSC staff strongly recommends against their use as a repair method.

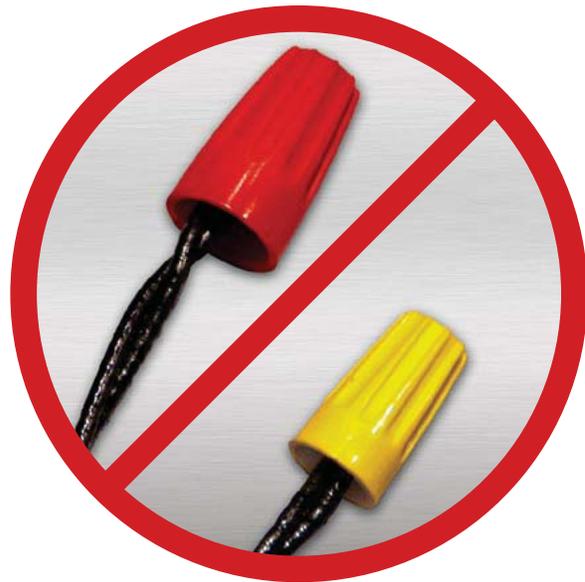
“Pigtailting” with Twist-on Connectors Is Not a Recommended Repair

The first temporary repair involves pigtailting with a twist-on connector. The effectiveness of “pigtailting” using twist-on connectors has been evaluated by CPSC staff. In CPSC-sponsored laboratory testing and life tests, substantial numbers of these connectors overheated severely.

of twist-on connectors with aluminum wire. It is possible that some pigtailting “repairs” made with twist-on connectors may be prone to even more failures than the original aluminum wire connectors. Accordingly, CPSC staff believes that this method of repair does not solve the problem of overheating present in aluminum-wired branch circuits.
